MISCELLANEOUS PAPER SL-79-17

TESTING OF 6-IN.-DIAMETER CONCRETE CORES FROM MARTIN DAM ALABAMA POWER COMPANY

Structures Laboratory
U. S. Army Engineer Waterways Experiment Station
P. O. Box 631, Vicksburg, Miss. 39180

August 1979

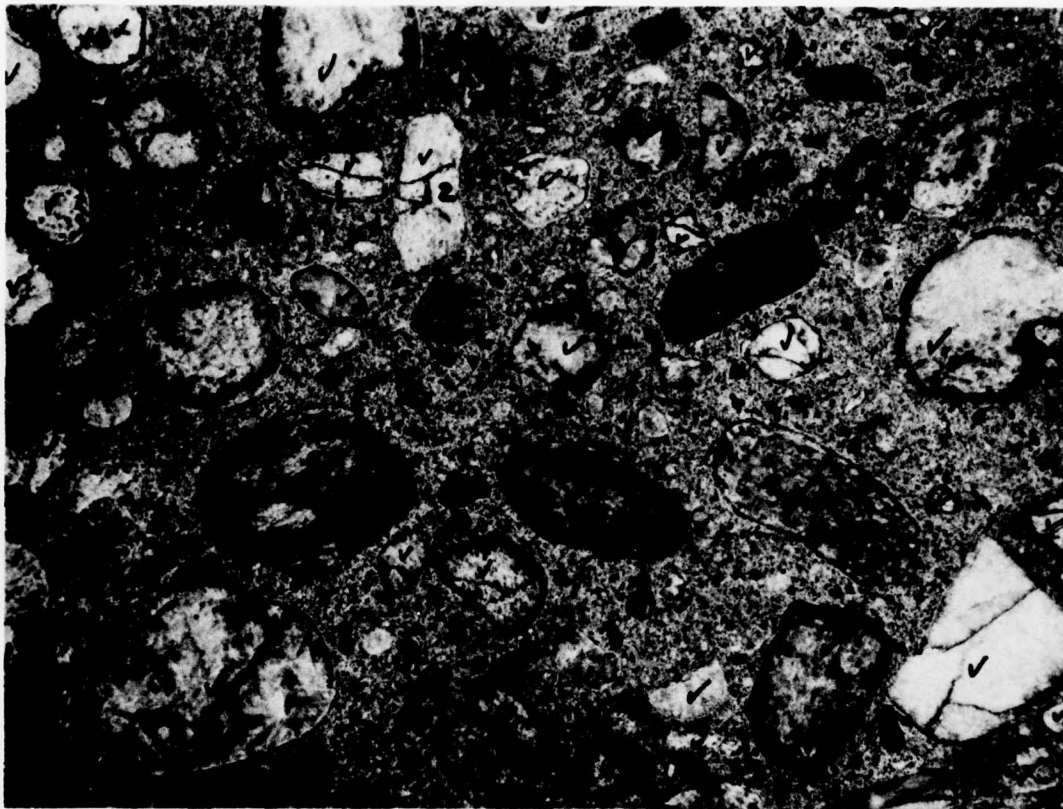
12. "Main cracks" in the coarse aggregate are shown in Photo A2. Main cracks were described and illustrated by Idorn (1964). Photo A2, at 1X, has every piece of coarse aggregate marked in which either main cracks or disintegration of the siliceous cement in the center of quartzite particles could be recognized at 10X to 30X. Main cracks were much more abundant than disintegration of the siliceous cement. The extension of main cracks into the mortar represents a more advanced degree of reaction than was often found in the cores from Martin Dam examined here. Two plates reproduced from Idorn's report are shown as Figures A1 and A2 to clarify the concept and details of main cracks in aggregate and mortar. Alkali-silica gel was found coating the surfaces of the crack shown in the upper left-hand corner of Photo A2.

The evidence was white to translucent alkali-silica gel in voids, in aggregate sockets, and in cracks; reaction rims on quartz and quartzite particles; and as cracks that could be traced across these aggregate particles into the paste (Photo A2).

Photo A2. Sawed ground surface of CL-24 DC-10A illustrates main cracks, 1X. Every particle with a check mark shows a main crack or disintegration of the interior of the aggregate at a magnification of 10X - 20X. At the upper left margin of the left side a crack in the mortar runs subparallel to the upper margin and is probably related to the main cracks in the particles marked 1 and 2. Rims or partial rims are common.

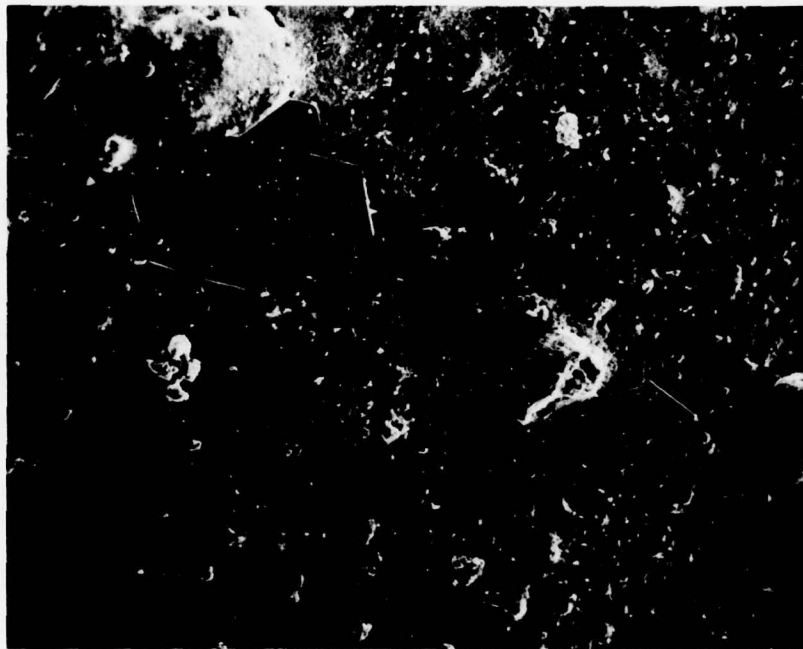
Photo A3. SEM photomicrograph of several elongated and platy monosulfoaluminate crystals found in a void in piece CL-24(3) DC-7C, 52X.

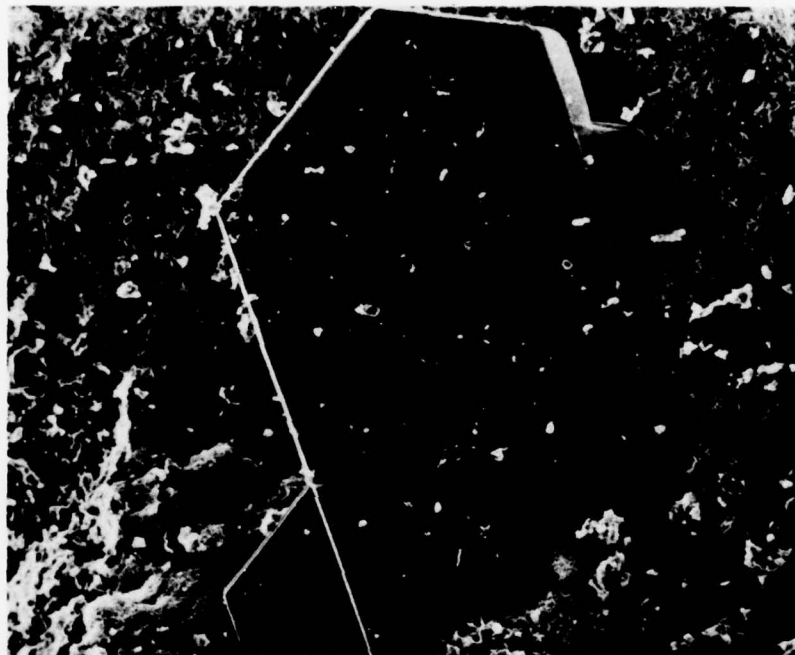
Photo A4. SEM photomicrograph of another group of monosulfoaluminate crystals found in a void in piece CL-24(3) DC-7C, 194X.

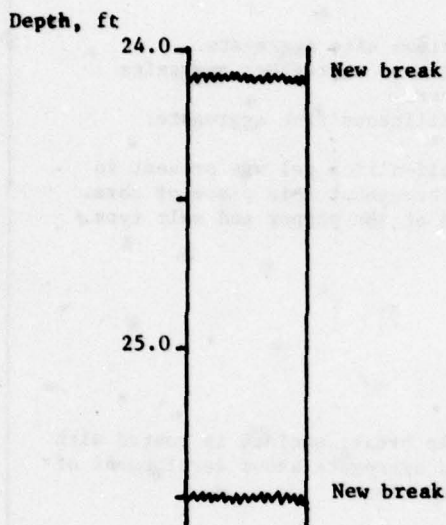
Depth (ft) 24.1 - 25.5
Elevation 477.4 - 476.0
(ft msl)

3-in. maximum size aggregate.
Natural coarse aggregate; quartzite
and quartz.
Natural siliceous fine aggregate.

Some alkali-silica gel present in voids
throughout this piece of core.

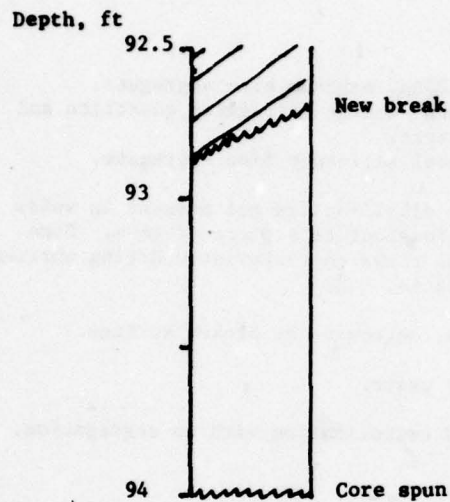
Depth (ft) 92.7 - 94.0
Elevation 408.8 - 407.5
(ft msl)

4-in. maximum size aggregate.
Natural coarse aggregate; quartzite and
quartz.
Natural siliceous fine aggregate.

Some alkali-silica gel present in voids
throughout this piece of core.

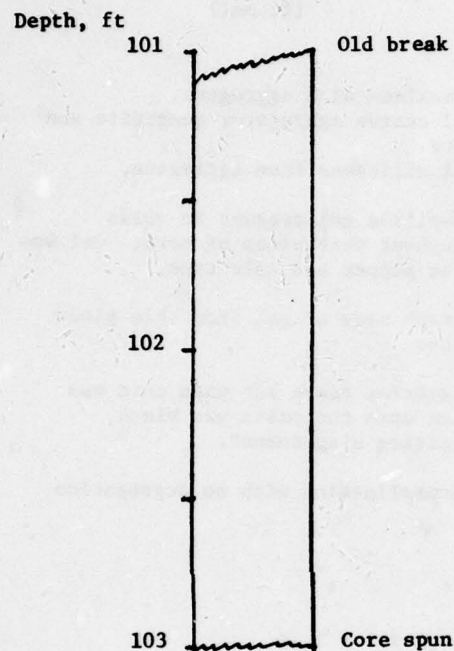
Depth (ft) 101.0 - 103.0
Elevation 400.5 - 398.5
(ft msl)

1-1/2-in. maximum size aggregate.
Natural coarse aggregate; quartzite and
quartz.
Natural siliceous fine aggregate.

Abundant alkali-silica gel in voids
throughout this piece of core.

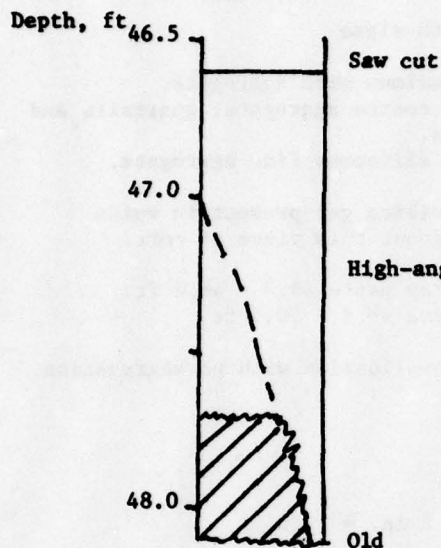
Depth (ft) 46.6 - 48.1
Elevation 454.9 - 453.4
(ft msl)

4-in. maximum size aggregate.
Natural coarse aggregate; quartzite and
quartz.
Natural siliceous fine aggregate.

High-angle incipient crack

Some alkali-silica gel in voids and coating
some aggregates. The gel showed some
shrinkage cracking. Other voids were
filled with needles of ettringite.
